# REDDINGTON LEVEE SETBACK PROJECT

## YEAR 1 MONITORING REPORT

Corps Reference Number: NWS-2010-1183

December 29, 2014  
Monitoring Year 1 of 10

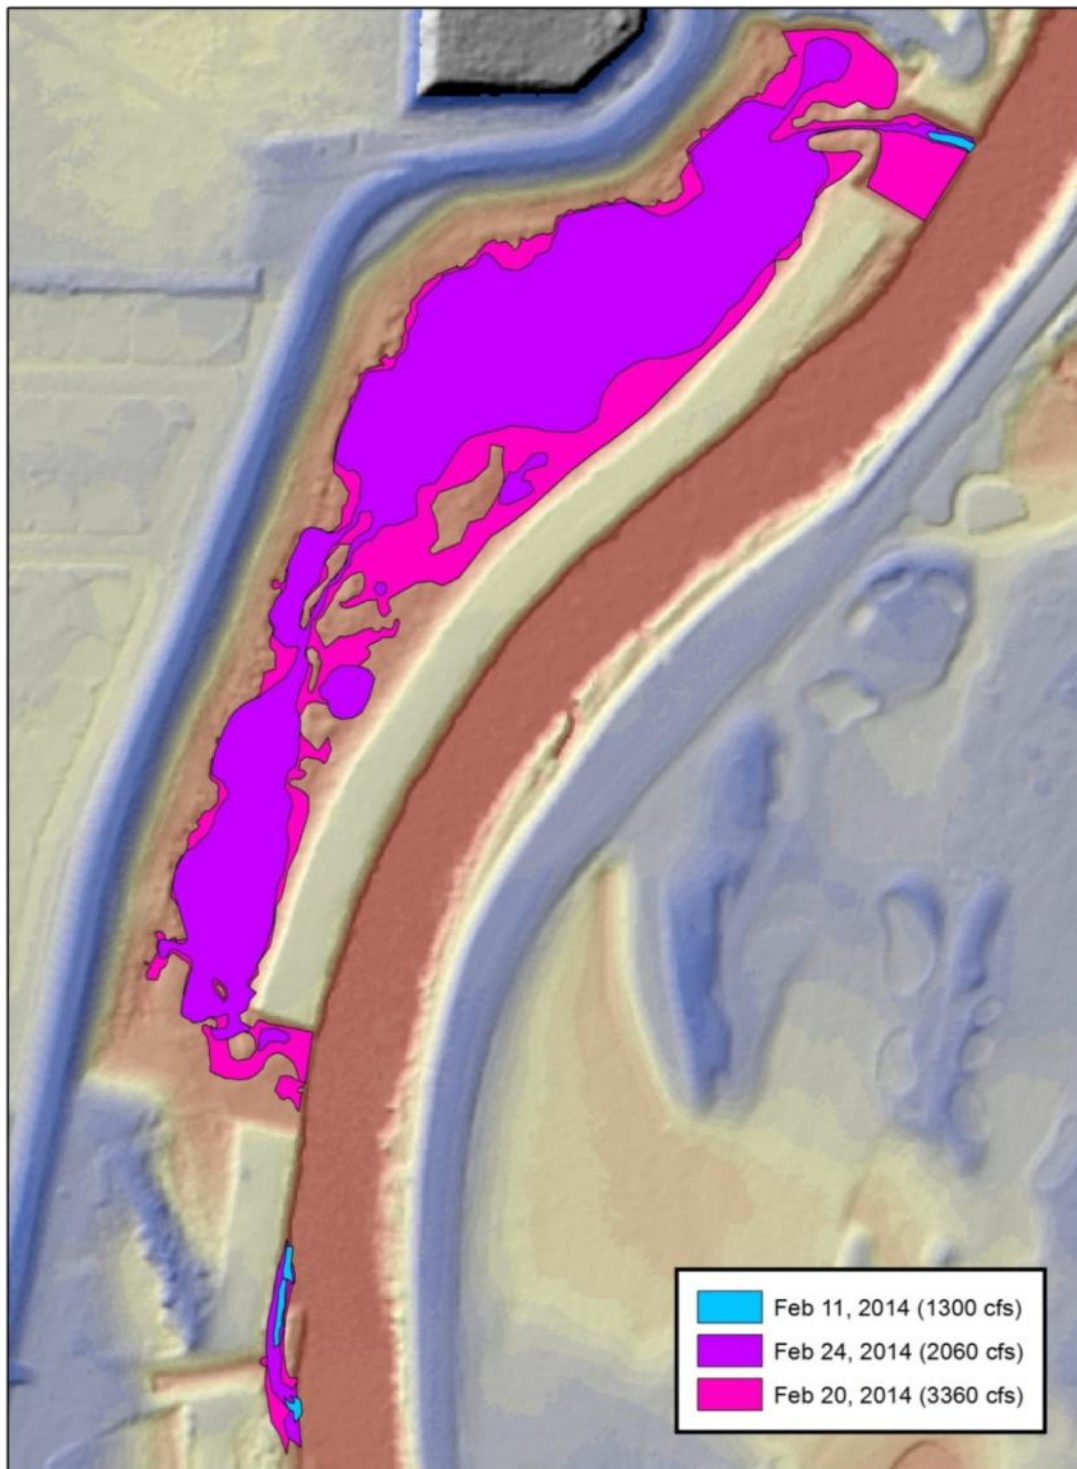
FIGURE 6. TOTAL POST CONSTRUCTION EDGE HABITAT IN THE LOWER PROJECT AREA AT 3 DIFFERENT DISCHARGES.

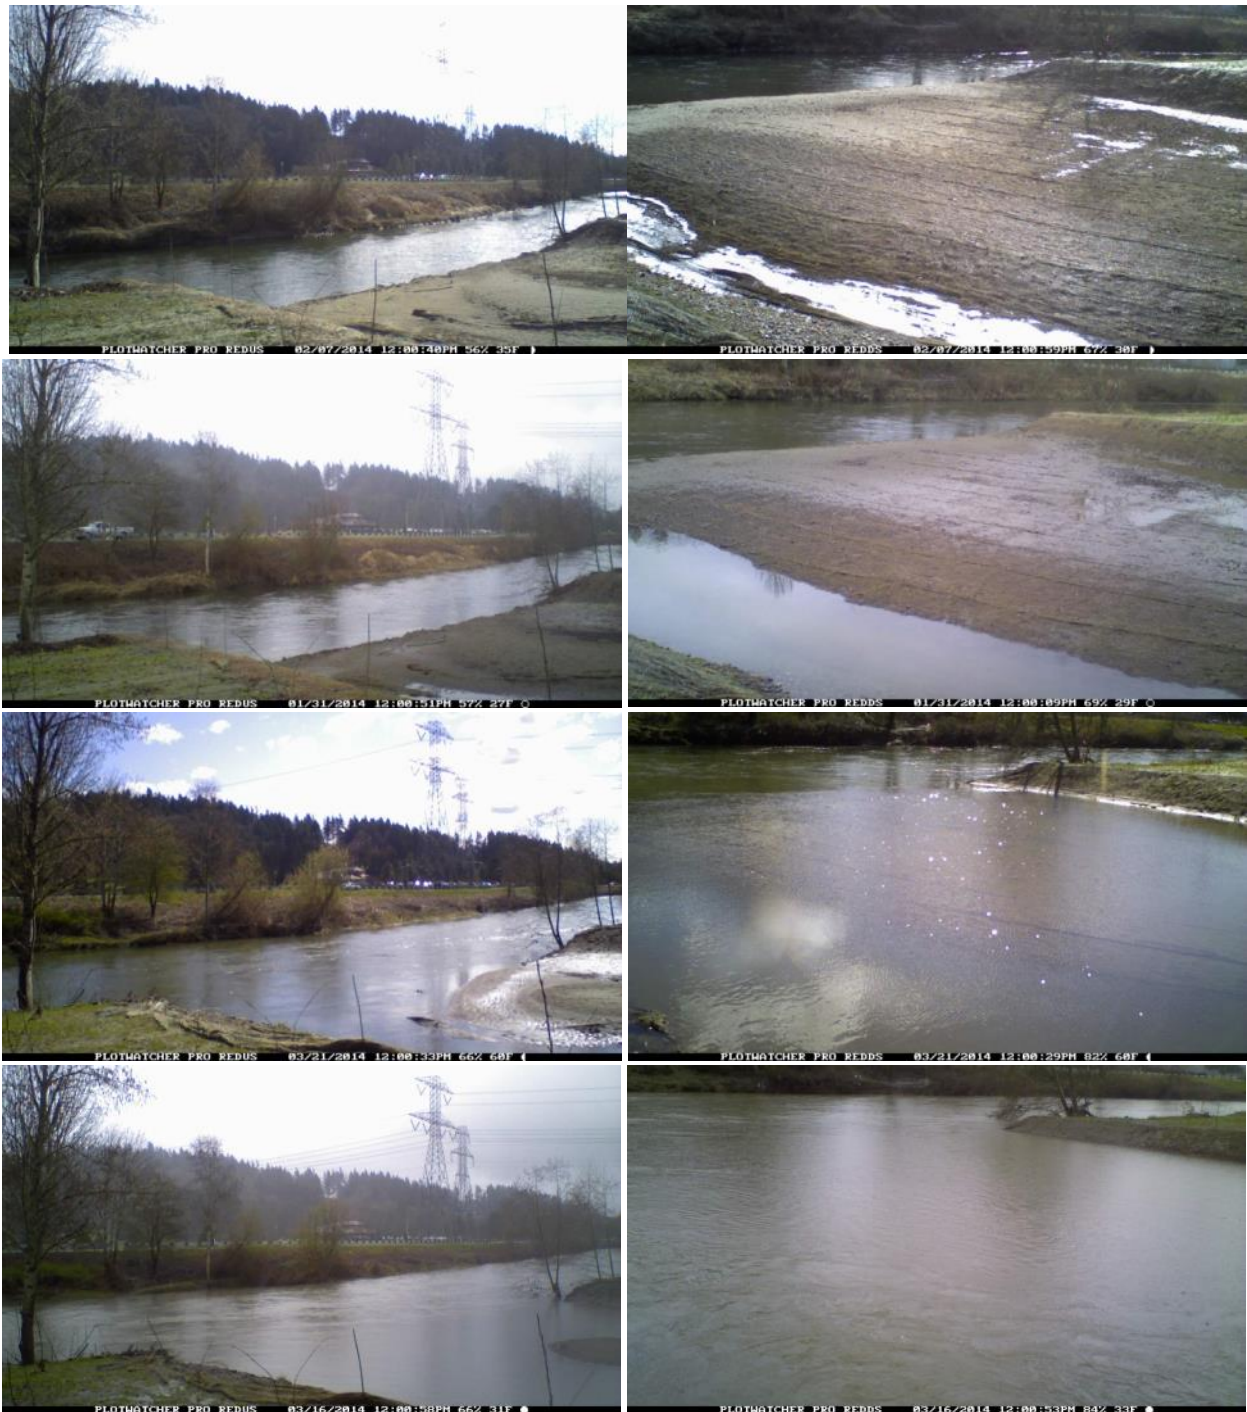
<b>Connected (cfs)</b>	<b>Time Connected to River (Jan1-Jun30)</b>
<b>Inlet (upstream)</b>	≥2,410	29%
<b>Outlet (downstream)</b>	≥1,420	70%

FIGURE 8. SIDE CHANNEL INLET (LEFT) AND OUTLET (RIGHT) AT FOUR FLOWS FROM TOP TO BOTTOM: 924 CFS ON 2/7/14, 2,010CFS ON 1/31/14, 3,000CFS ON 3/21/14, AND 4,250CFS ON 3/16/14.

Continue monitoring side channel connection using remote cameras in Years 3, 5, 7 and 10 post-construction to document flow-through and backwater conditions. Add side channel connection monitoring in Year 2 (2015) to document changes resulting from additional inlet excavation in 2014.

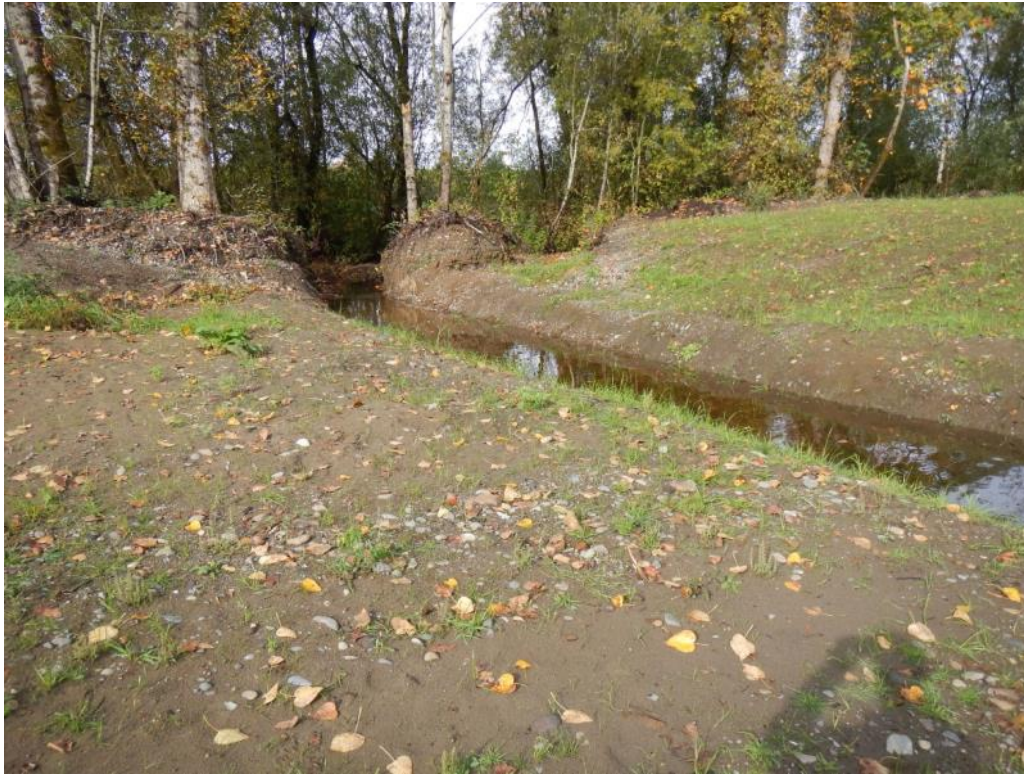
Following survey and completion of record drawings, it was noted that the inlet to the side channel (Wetland E) was higher than designed. Accordingly, a lower flow inlet was excavated in 2014 to allow for more frequent inundation.

A small one-foot deep trench was excavated at the side channel inlet in Summer 2014 in order to allow more water to flow into the wetland area (Figure 9).

FIGURE 9. EXCAVATED TRENCH, LOOKING TOWARD THE WETLAND, AT THE UPSTREAM NOTCH.
